**Flood Control Project Maintenance
Levee Inspections**
LMA District Cover Sheet
Spring 2017 Levee Inspection Results

Reclamation District No. 0827 Elkhorn

Levee Inspection Report By Mile - Spring 2017

Waterway	Bank	Unit Miles	Inspection Start/End	Inspector
Unit No. 01 Sacramento River	Right	1.34	04/12/2017 04/12/2017	Zach Jojola

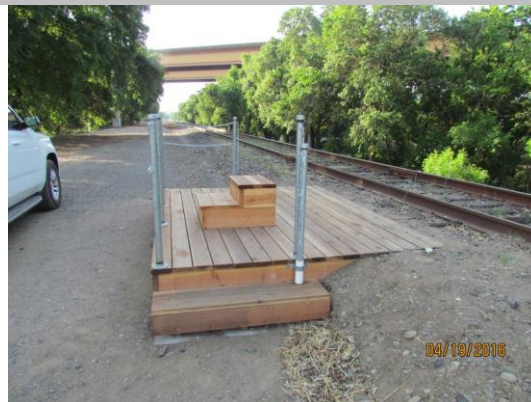
Photo 1 of 1 : SP_2017_RD0827_187_10_20170320_00003.jpg

LM Start	0.11	Rating **	M	Issue No.	10
LM End	0.11	Issue Type +	En	Location *	CR
Category	Earthen Levee			GPS Latitude/Longitude	
				Start	End
Item	Encroachments			38.674133 °	38.674133 °
				-121.629097 °	-121.629097 °
DWR ID	DWR_RD0827_01_s_2016_10				
Comment Code					
ST : Stairway					
Inspector Comment					
Railroad has put steps on the crown for the tourist train from the West City of Sac water plant. Stairs are not permitted and was placed this year Spring 2016.

View of the stairs on the crown of the levee looking downstream. Spring 2016.

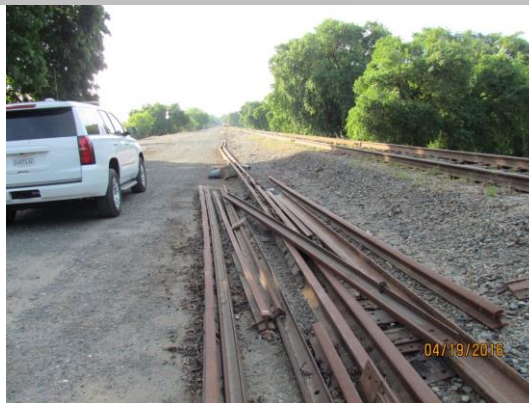
Photo 1 of 1 : SP_2017_RD0827_187_12_20170320_00004.jpg

LM Start	0.24	Rating **	M	Issue No.	12
LM End	0.53	Issue Type +	En	Location *	CR
Category	Earthen Levee			GPS Latitude/Longitude	
				Start	End
Item	Encroachments			38.672749 °	38.669781 °
				-121.627333 °	-121.623587 °
DWR ID	DWR_RD0827_01_s_2016_12				
Comment Code					
MA : Material					
Inspector Comment					
RR rails and ties on the levee crown.

View of the rails on the crown of the levee looking downstream. Spring 2016.

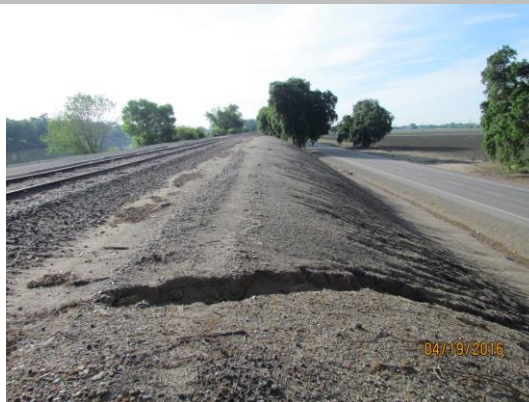
Photo 1 of 2 : SP_2017_RD0827_187_13_20170320_00005.jpg

LM Start	0.51	Rating **	M	Issue No.	13
LM End	0.51	Issue Type +	Ma	Location *	LS
Category	Earthen Levee			GPS Latitude/Longitude	
				Start	End
Item	Erosion / Bank Caving			38.669929 °	38.669929 °
				-121.623776 °	-121.623776 °
DWR ID	DWR_RD0827_01_s_2016_13				
Comment Code					
E2 : Schedule repair of erosion site prior to the next inspection.					
Inspector Comment					
Rills caused by rain.

View of the erosion on the landward side of the levee looking downstream. Spring 2016.

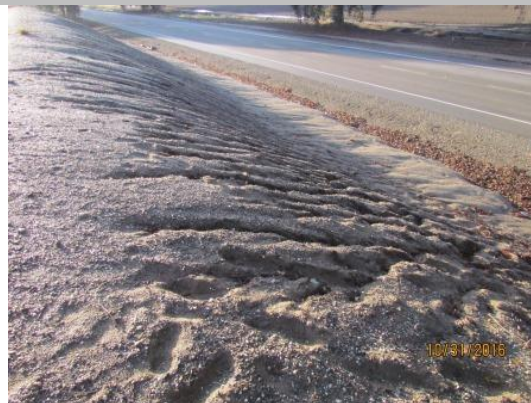
Photo 2 of 2 : SP_2017_RD0827_187_13_20170320_00006.jpg

LM Start	0.51	Rating **	M	Issue No.	13 (cont)	
LM End	0.51	Issue Type +	Ma	Location *	LS	
Category	Earthen Levee			GPS Latitude/Longitude		
				Start		End
Item	Erosion / Bank Caving			38.669929 °		38.669929 °
				-121.623776 °		-121.623776 °
DWR ID	DWR_RD0827_01_s_2016_13					
Comment Code						
E2 : Schedule repair of erosion site prior to the next inspection.						
Inspector Comment						
Rills caused by rain.

Updated view of runoff erosion site. LS slope. Fall 2016.

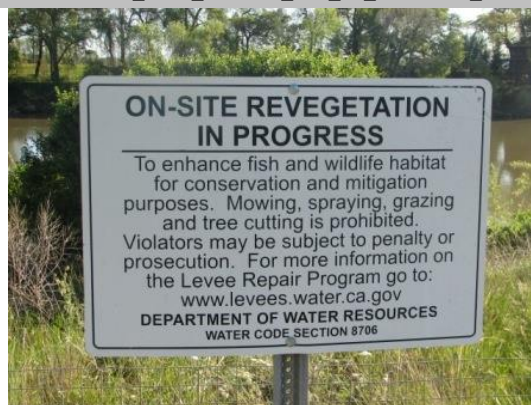
Photo 1 of 2 : SP_2017_RD0827_187_22_20170320_00007.jpg

LM Start	0.61	Rating **	A/W	Issue No.	22
LM End	0.92	Issue Type +	Ma	Location *	WS
Category	Earthen Levee			GPS Latitude/Longitude	
				Start	End
Item	Vegetation			38.668873 °	38.665750 °
				-121.622513 °	-121.618523 °
DWR ID	DWR_RD0827_01_s_2012_22				
Comment Code					
V8 : Environmental Requirements.					
Inspector Comment

Revegetation site spring 2012.

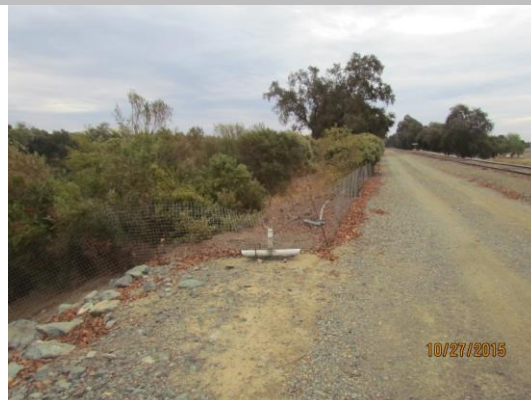
Photo 2 of 2 : SP_2017_RD0827_187_22_20170320_00008.jpg

View of the revegetation site on the waterward side of the levee looking downstream. Fall 2015.

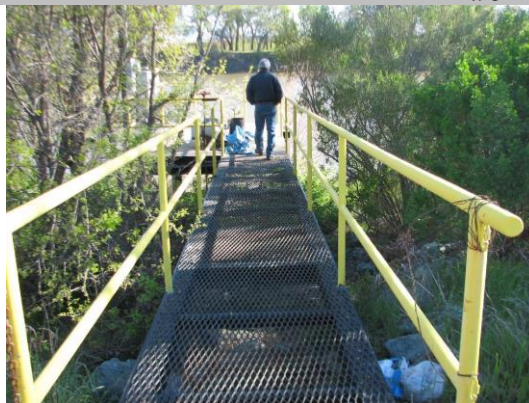
Photo 1 of 3 : UCIP_SP_2017_38983_59737.jpg

Comment Code					
Inspector Comment					
FS_ID:38983 DS_ID:21147 EP_NO: N/A Repair Type: Non-Urgent Crossing Status: Found UCIP Comments: Need to contact owner to obtain additional information for this crossing. This crossing does not match original description listed in desk study. Need to coordinate with owner to obtain permit number authorizing modification. FIELD_STRUCT_DESC: 14-inch (not 16-inch as listed in desk study) pipe through the levee, 10.3 feet below the crown. 10-inch bypass pipe on waterward side. Siphon breaker on landward (not waterward) shoulder. Pump on platform (not mounted on 48-inch concrete pipe as described in desk study) on waterward bank. Metal (not wooden) walkway to the pump. 3/4-inch conduit through levee at unknown depth. FS Date: 3/18/2014

Platform for pump located on waterward side.

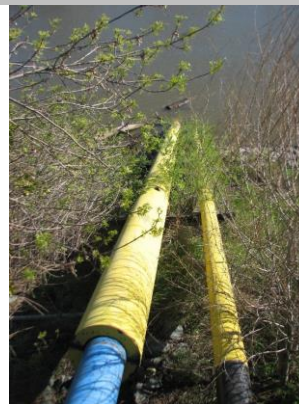
Photo 2 of 3 : UCIP_SP_2017_38983_59736.jpg

Pipe visible on waterward side.

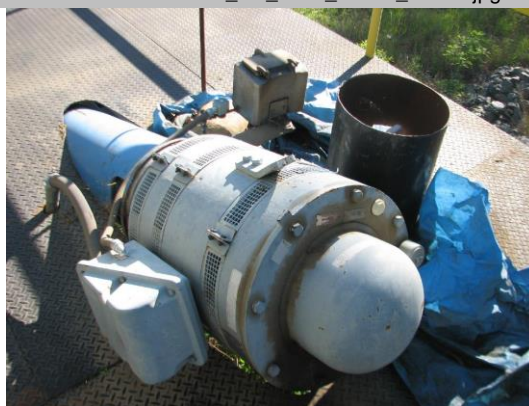
Photo 3 of 3 : UCIP_SP_2017_38983_59735.jpg

Item	DWR UCIP Field Study			38.667731 °	38.667731 °	
				-121.620992 °	-121.620992 °	
DWR ID						
Comment Code						
Inspector Comment						
FS_ID:38983 DS_ID:21147 EP_NO: N/A Repair Type: Non-Urgent Crossing Status: Found UCIP Comments: Need to contact owner to obtain additional information for this crossing. This crossing does not match original description listed in desk study. Need to coordinate with owner to obtain permit number authorizing modification. FIELD_STRUCT_DESC: 14-inch (not 16-inch as listed in desk study) pipe through the levee, 10.3 feet below the crown. 10-inch bypass pipe on waterward side. Siphon breaker on landward (not waterward) shoulder. Pump on platform (not mounted on 48-inch concrete pipe as described in desk study) on waterward bank. Metal (not wooden) walkway to the pump. 3/4-inch conduit through levee at unknown depth. FS Date: 3/18/2014

Slant pump located on waterward side.

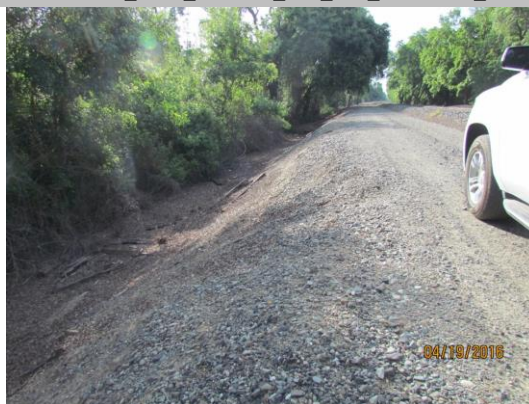
Photo 1 of 1 : SP_2017_RD0827_187_213_20170320_00011.jpg

LM Start	0.96	Rating **	M	Issue No.	213
LM End	0.96	Issue Type +	Ma	Location *	WS
Category	Earthen Levee			GPS Latitude/Longitude	
				Start	End
Item	Slope Stability			38.665307 °	38.665307 °
				-121.617982 °	-121.617982 °
DWR ID	DWR_RD0827_01_s_2015_213				
Comment Code					
S1 : Repair slope instability.					
Inspector Comment

View of the slope instability on the waterward side of the levee looking downstream. Spring 2016.

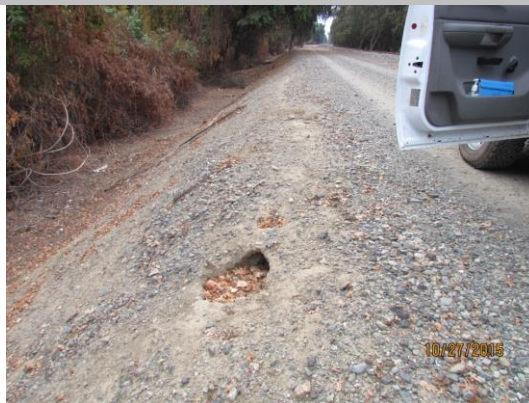
Photo 1 of 1 : SP_2017_RD0827_187_8_20170320_00002.jpg

View of the rodent hole on the waterward side of the levee looking downstream. Fall 2015.

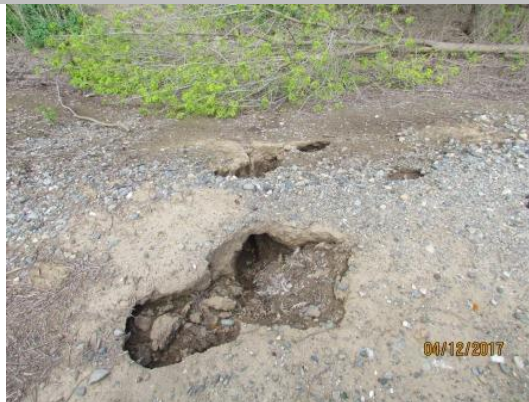
Photo 1 of 3 : SP_2017_RD0827_187_3_20170413_00015.jpg

LM Start	1.12	Rating **	M	Issue No.	3
LM End	1.12	Issue Type +	Ma	Location *	WS
Category	Earthen Levee			GPS Latitude/Longitude	
				Start	End
Item	Erosion / Bank Caving			38.663542 °	38.663542 °
				-121.616056 °	-121.616056 °
DWR ID	DWR_RD0827_01_f_2016_3				
Comment Code					
E2 : Schedule repair of erosion site prior to the next inspection.					
Inspector Comment					
Erosion on the crown and levee slope that has become worse due to runoff.

Updated view of erosion on waterside levee slope. Spring 2017.

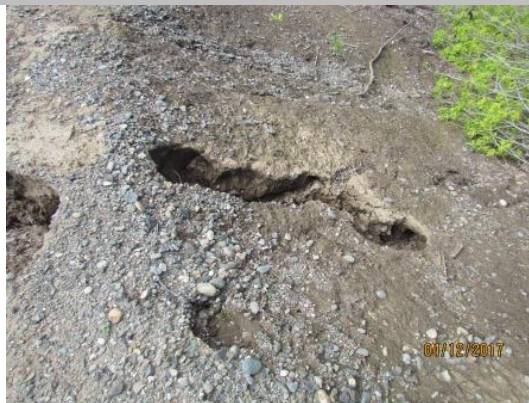
Photo 2 of 3 : SP_2017_RD0827_187_3_20170413_00017.jpg

LM Start	1.12	Rating **	M	Issue No.	3 (cont)	
LM End	1.12	Issue Type +	Ma	Location *	WS	
Category	Earthen Levee			GPS Latitude/Longitude		
				Start		End
Item	Erosion / Bank Caving			38.663542 °		38.663542 °
				-121.616056 °		-121.616056 °
DWR ID	DWR_RD0827_01_f_2016_3					
Comment Code						
E2 : Schedule repair of erosion site prior to the next inspection.						
Inspector Comment						
Erosion on the crown and levee slope that has become worse due to runoff.

Another view of erosion on levee slope. A hole on the waterside slope has widened due to runoff. Spring 2017.

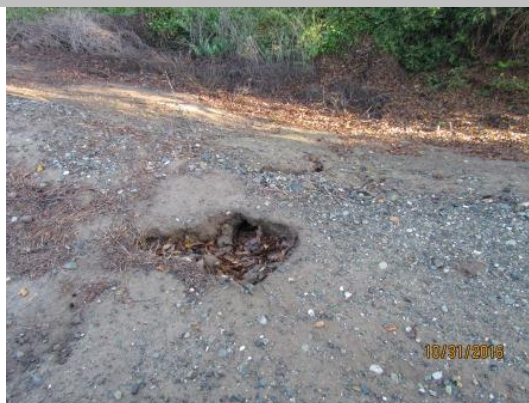
Photo 3 of 3 : SP_2017_RD0827_187_3_20170320_00001.jpg

View of erosion on crown continuing to WS slope. Fall 2016.

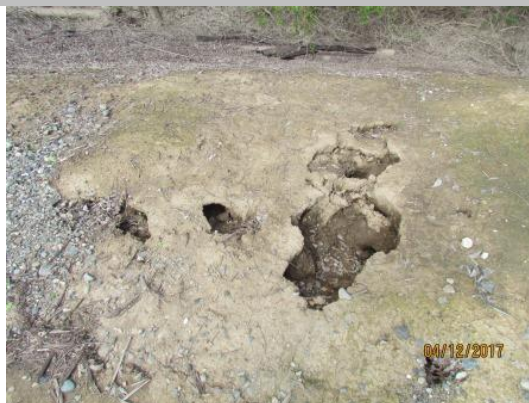
Photo 1 of 1 : SP_2017_RD0827_187_14_20170413_00018.jpg

LM Start	1.14	Rating **	M	Issue No.	14
LM End	1.14	Issue Type +	Ma	Location *	WS
Category	Earthen Levee			GPS Latitude/Longitude	
				Start	End
Item	Erosion / Bank Caving			38.663377 °	38.663377 °
				-121.615895 °	-121.615895 °
DWR ID	DWR_RD0827_01_s_2017_14				
Comment Code					
E2 : Schedule repair of erosion site prior to the next inspection.					
Inspector Comment

View of erosion on waterside levee slope. Spring 2017.

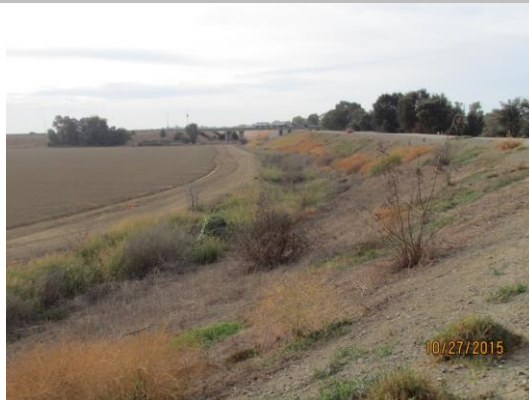
Photo 1 of 1 : SP_2017_RD0827_188_2_20170320_00001.jpg

LM Start	0.02	Rating **	C	Issue No.	10
LM End	0.02	Issue Type +	Ma	Location *	LS
Category	Earthen Levee			GPS Latitude/Longitude	
				Start	End
Item	Erosion / Bank Caving			38.676549 °	38.676549 °
				-121.642703 °	-121.642703 °
DWR ID	DWR_RD0827_02_f_2015_10				
Comment Code					
E2 : Schedule repair of erosion site prior to the next inspection.					
Inspector Comment					
It seems like someone poured water onto the levee slope and caused an erosion on the slope.

View of the ditch on the landward side of the levee looking downstream. Fall 2015.

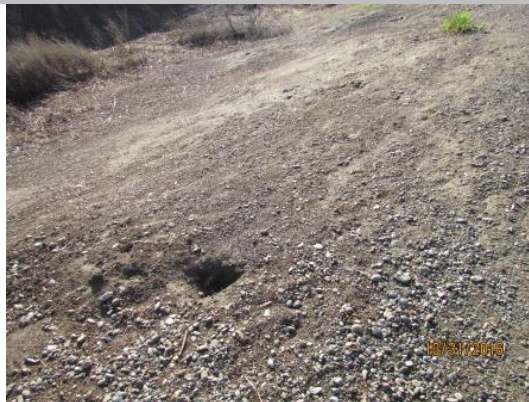
Photo 1 of 1 : SP_2017_RD0827_188_7_20170320_00004.jpg

LM Start	0.11	Rating **	M	Issue No.	7
LM End	0.11	Issue Type +	Ma	Location *	LS
Category	Earthen Levee			GPS Latitude/Longitude	
				Start	End
Item	Animal Control			38.675326 °	38.675326 °
				-121.643042 °	-121.643042 °
DWR ID	DWR_RD0827_02_f_2016_7				
Comment Code					
A3 : No rodents visible, but rodent burrows visible; need to backfill and compact or grout burrows.					
Inspector Comment

Rodent holes on LS levee slope. Fall 2016.

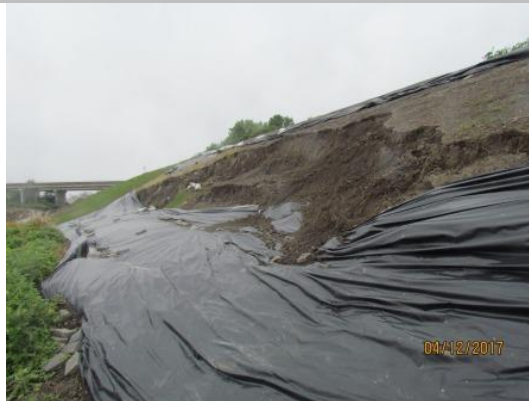
Photo 1 of 1 : SP_2017_RD0827_188_11_20170413_00024.jpg

LM Start	0.16	Rating **	U	Issue No.	11
LM End	0.16	Issue Type +	Ma	Location *	LS
Category	Earthen Levee			GPS Latitude/Longitude	
				Start	End
Item	Erosion / Bank Caving			38.674523 °	38.674523 °
				-121.642767 °	-121.642767 °
DWR ID	DWR_RD0827_02_s_2017_11				
Comment Code					
E2 : Schedule repair of erosion site prior to the next inspection.					
Inspector Comment					
100' section of sloughing on landside levee slope.

View of sloughing on landside levee slope. LMA placed visqueen to prevent further erosion, which has since fallen down. Spring 2017.

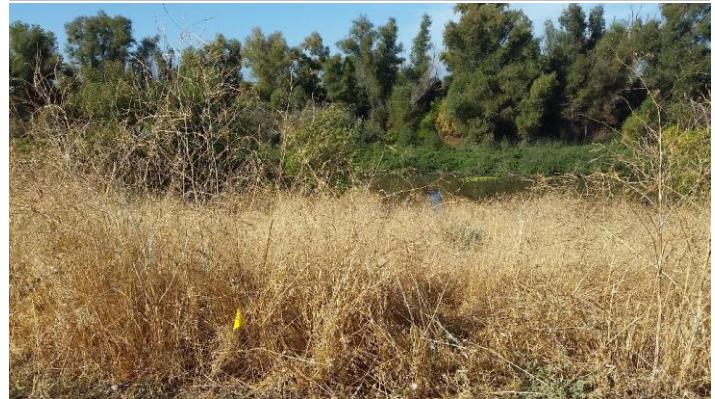
Photo 1 of 3 : UCIP_SP_2017_50065_75673.jpg

FS_ID:50065
DS_ID:24844
EP_NO: 17403
Repair Type: Non-Urgent
Crossing Status: Indicator Found
UCIP Comments: 9/27/2016 Need to coordinate with Greg Lucas (gregory.lucas@crc.com) with California Resources Corporation to determine if line will be brought online. Crossing was downgraded from Urgent to Non-Urgent--new owner has not brought the pipe online. New owner will need to update permit name and if line becomes active markers will be required per Title 23. (DWR UCIP - omagana)9/02/2016 Meet with Jimmy Preston from California Resources Corporation at site. Alignment of crossing was confirmed (new location is approximately 290 feet upstream from previous point)--report has been updated. Pending action -- Name Change (DWR UCIP - omagana)9/01/2016 Email was sent to Greg Lucas from California Resources Corporation with an updated UCIP detailed report and Central Valley Flood Protection Board (CVFPB) name change form. New owner will need to update permit information with the CVFPB to be compliant with Title 23 requirements. (DWR UCIP - omagana)8/31/2016 New owner--California Resources Corporation. Gas line is currently not in use. Meet with Greg Lucas, Assistant Production Coordinator from California Resources Corporation and Steve Stein from Noble Methan, Inc. to clarify current status of crossing and determine crossing alignment. Gas well is part of the gas line appurtenances. Gas line alignment is still pending--California Resources Corporation will send out someone to confirm alignment. Crossing is missing markers, if line becomes active markers will be needed on both the WS and LS to comply with Title 23--encouraged owner to contact CVFPB. (DWR UCIP - omagana)8/30/2016 Coordinating with AA Production Services, Inc. to determine location of where crossing goes through levee. It appears that the gas well located on LS is not part of this crossing. (DWR UCIP - omagana)8/04/2016 Meet with Bill Mattos, representative of RD 827, and he took me to the gas well visible from levee crown. Mr. Mattos was unable to confirm if gas well and pipeline that goes through the levee were connected. 3/18/2014 No markers visible on either banks. Need to contact owner to determine status of crossing. Need date of last inspection and confirmation that crossing is still in operable condition. (DWR UCIP - omagana)

View of WS--Tule Canal.

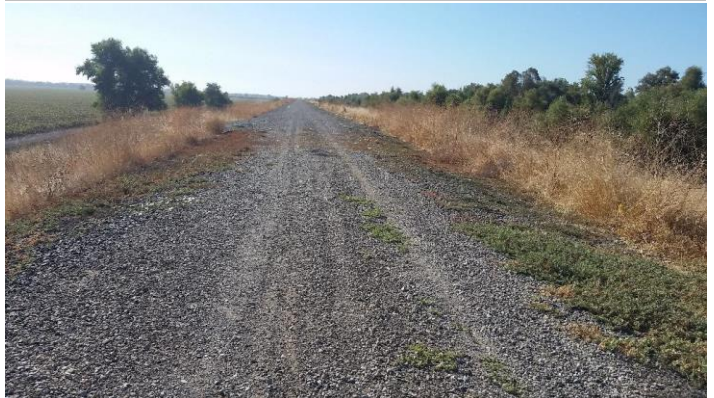
Photo 2 of 3 : UCIP_SP_2017_50065_75672.jpg

View of levee crown at crossing--yellow flag markers visible on both WS and LS shoulder.

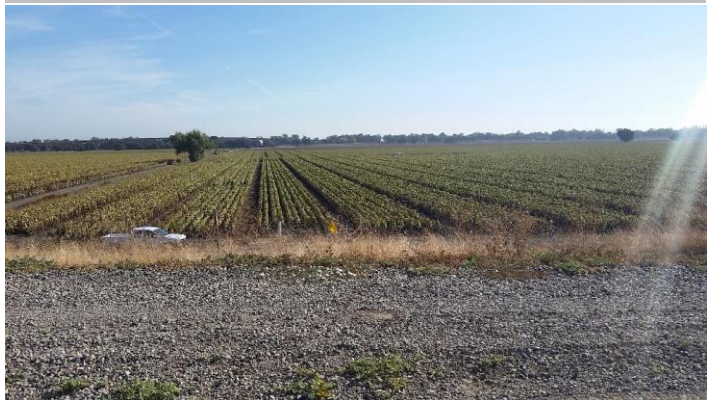
Photo 3 of 3 : UCIP_SP_2017_50065_75671.jpg

View of LS.

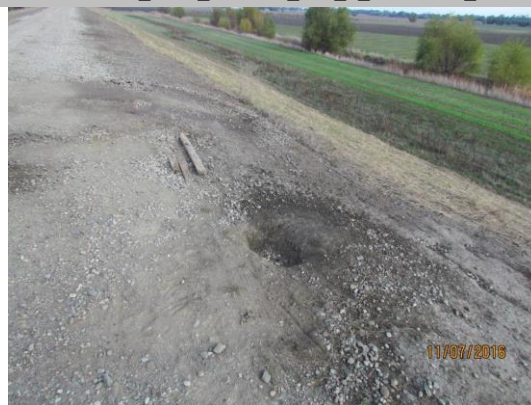
Photo 1 of 1 : SP_2017_RD0827_188_9_20170320_00006.jpg

LM Start	2.01	Rating **	M	Issue No.	9
LM End	2.01	Issue Type +	Ma	Location *	CR
Category	Earthen Levee			GPS Latitude/Longitude	
				Start	End
Item	Crown Surface / Depressions / Rutting			38.651270 °	38.651270 °
				-121.626661 °	-121.626661 °
DWR ID	DWR_RD0827_02_f_2016_9				
Comment Code					
C2 : Repair depressions or ruts in the crown or slope.					
Inspector Comment

View of crown depression site. Fall 2016.

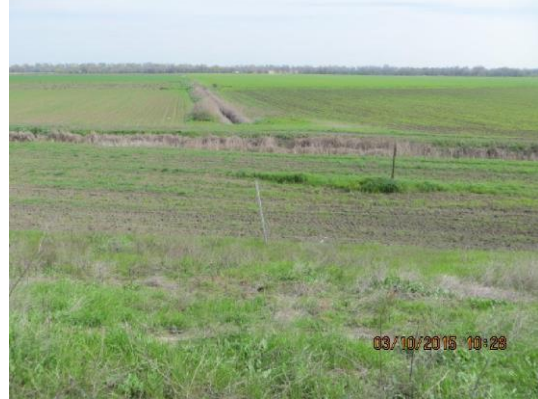
Photo 1 of 3 : UCIP_SP_2017_50030_73360.jpg

FS_ID:50030
DS_ID:21159
EP_NO: 15904
Repair Type: Urgent
Crossing Status: Indicator Found
UCIP Comments: 8/31/2016 Meet with Greg Lucas, Assistant Production Coordinator from California Resources Corporation and Steve Steim from Noble Methan, Inc. to discuss the status of a different line upstream. Mr. Steve Steim was aware of the 3-inch line by Two Bay Petroleum as known as a PG&E old pipe at this location. According to Steve Stein the appurtenances previously located on the landside have been removed and the 3-inch line abandoned. Need to contact owner to confirm status of crossing. If crossing is no longer in use the owner will need to coordinate with CVFPB to comply with Title 23. (DWR UCIP - omagana)8/04/2016 No markers found on either WS or LS. Need to coordinate with owner to determine status of crossing. (DWR UCIP - omagana)3/10/2015 Sign missing on WS and LS. Need to confirm status of crossing with permittee. Appears abandoned. (DWR UCIP - wwylie)

03/18/2014 crossing not found. (DWR UCIP - omagana)
FIELD_STRUCT_DESC: 3-inch steel pipe through the levee, 20 feet below the crown. Sign on waterside (WS) (not found 2015). Yellow pipe visible east of ditch approximately 150 feet off landside (LS) toe.
Contact Number 415-459-3445 for Two Bay Petroleum also referred as Pacific Energetics, Inc. (Permit No. 15904, 1992 - Two Bay Petroleum)
FS Date: 8/4/2016

View of LS.

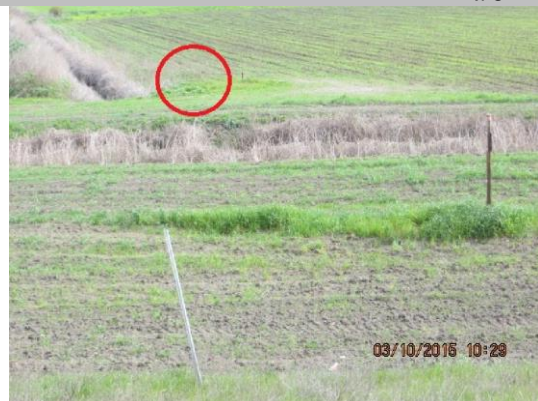
Photo 2 of 3 : UCIP_SP_2017_50030_73361.jpg

Pipe visible east of ditch approximately 150 ft off LS toe.

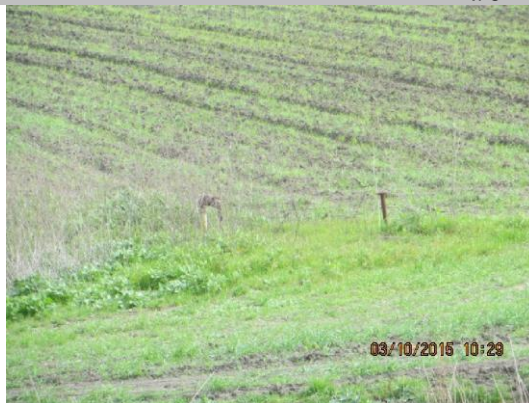
Photo 3 of 3 : UCIP_SP_2017_50030_73362.jpg

Item	DWR UCIP Field Study			38.651052 °	38.651052 °	
				-121.626501 °	-121.626501 °	
DWR ID						
Comment Code						
Inspector Comment						
FS_ID:50030 DS_ID:21159 EP_NO: 15904 Repair Type: Urgent Crossing Status: Indicator Found UCIP Comments: 8/31/2016 Meet with Greg Lucas, Assistant Production Coordinator from California Resources Corporation and Steve Steim from Noble Methan, Inc. to discuss the status of a different line upstream. Mr. Steve Steim was aware of the 3-inch line by Two Bay Petroleum as known as a PG&E old pipe at this location. According to Steve Stein the appurtenances previously located on the landside have been removed and the 3-inch line abandoned. Need to contact owner to confirm status of crossing. If crossing is no longer in use the owner will need to coordinate with CVFPB to comply with Title 23. (DWR UCIP - omagana)8/04/2016 No markers found on either WS or LS. Need to coordinate with owner to determine status of crossing. (DWR UCIP - omagana)3/10/2015 Sign missing on WS and LS. Need to confirm status of crossing with permittee. Appears abandoned. (DWR UCIP - wwylie) 03/18/2014 crossing not found. (DWR UCIP - omagana) FIELD_STRUCT_DESC: 3-inch steel pipe through the levee, 20 feet below the crown. Sign on waterside (WS) (not found 2015). Yellow pipe visible east of ditch approximately 150 feet off landside (LS) toe. Contact Number 415-459-3445 for Two Bay Petroleum also referred as Pacific Energetics, Inc. (Permit No. 15904, 1992 - Two Bay Petroleum) FS Date: 8/4/2016

Yellow pipe visible off LS toe.

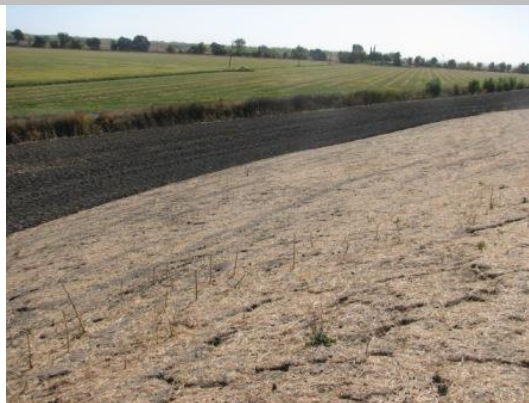
Photo 1 of 1 : SP_2017_RD0827_188_24_20170320_00010.jpg

LM Start	2.29	Rating **	A/W	Issue No.	24
LM End	2.29	Issue Type +	Ma	Location *	LS
Category	Earthen Levee			GPS Latitude/Longitude	
				Start	End
Item	Slope Stability			38.647703 °	38.647703 °
				-121.624450 °	-121.624450 °
DWR ID	DWR_RD0827_02_s_2012_24				
Comment Code					
S1 : Repair slope instability.					
Inspector Comment					
Cracking along the levee slope is less than 200 feet in length. Monitor the slope for changes in cracking.

A bulge in the levee slope. Photo fall 2012.

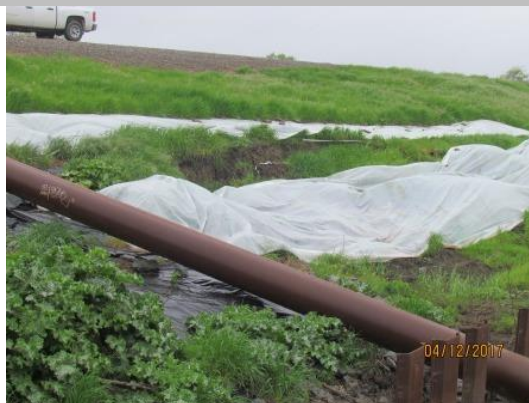
Photo 1 of 4 : SP_2017_RD0827_188_14_20170413_00025.jpg

LM Start	2.72	Rating **	M	Issue No.	14
LM End	2.74	Issue Type +	Ma	Location *	LS
Category	Earthen Levee			GPS Latitude/Longitude	
				Start	End
Item	Erosion / Bank Caving			38.642088 °	38.641817 °
				-121.620972 °	-121.620802 °
DWR ID	DWR_RD0827_02_s_2017_14				
Comment Code					
E2 : Schedule repair of erosion site prior to the next inspection.					
Inspector Comment					
Erosion on landside levee slope near LMA pump. Visqueen and bricks placed to prevent further erosion.

View of erosion and visqueen on landside levee slope. Spring 2017.

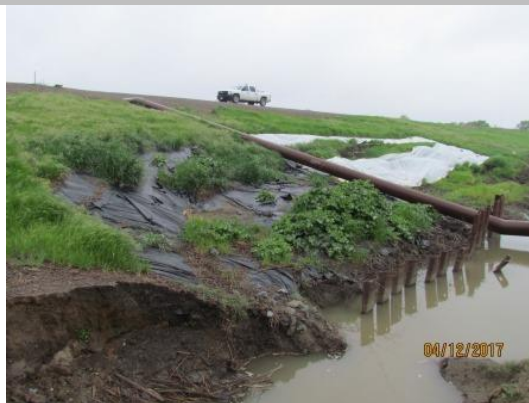
Photo 2 of 4 : SP_2017_RD0827_188_14_20170413_00026.jpg

Additional view of erosion on landside levee slope. Spring 2017.

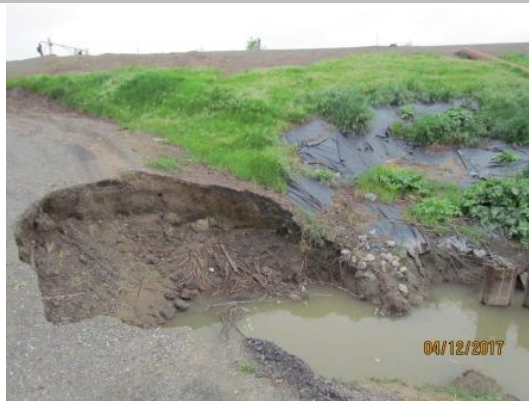
Photo 3 of 4 : SP_2017_RD0827_188_14_20170413_00028.jpg

LM Start	2.72	Rating **	M	Issue No.	14 (cont)	
LM End	2.74	Issue Type +	Ma	Location *	LS	
Category	Earthen Levee			GPS Latitude/Longitude		
				Start		End
Item	Erosion / Bank Caving			38.642088 °		38.641817 °
				-121.620972 °		-121.620802 °
DWR ID	DWR_RD0827_02_s_2017_14					
Comment Code						
E2 : Schedule repair of erosion site prior to the next inspection.						
Inspector Comment						
Erosion on landside levee slope near LMA pump. Visqueen and bricks placed to prevent further erosion.

Another view of erosion on landside levee slope. Spring 2017.

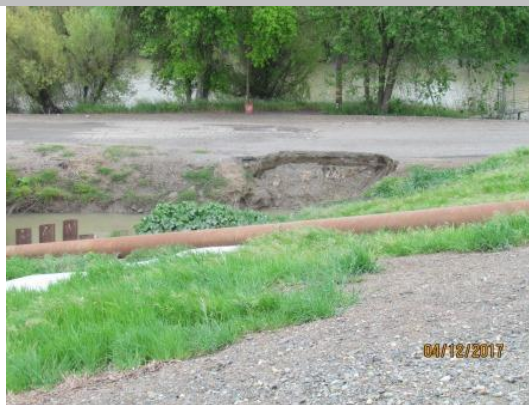
Photo 4 of 4 : SP_2017_RD0827_188_14_20170413_00027.jpg

Looking down levee slope. Spring 2017.

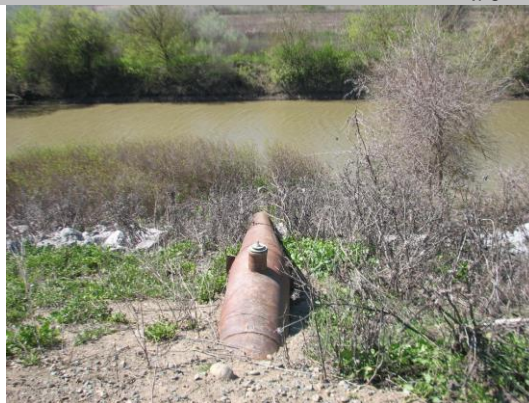
Photo 1 of 3 : UCIP_SP_2017_38984_59769.jpg

Comment Code					
Inspector Comment					
FS_ID:38984 DS_ID:21151 EP_NO: 3277 Repair Type: Non-Urgent Crossing Status: Found UCIP Comments: Crossing appears to have been removed and replaced under maintenance back in 2008. No permit has been found--need to contact owner to obtain additional information about replacement. Landward slope sloughing--does not appear to be associated with crossing. Landward slope is being monitored by LMA. FIELD_STRUCT_DESC: 18-inch (not 20-inch as noted in desk study) steel drainpipe through the levee, 4.0 feet below the crown. Cutoff wall around pipe at center of levee. Siphon breaker on apex of pipe at waterward shoulder. Pump on pipe structure in drainage ditch at landward toe. Rock revetment on waterward slope. Pipe retained through levee and updates required to crossing under Permit No. 3277 (1960). FS Date: 3/18/2014

View of pipe visible on waterward side.

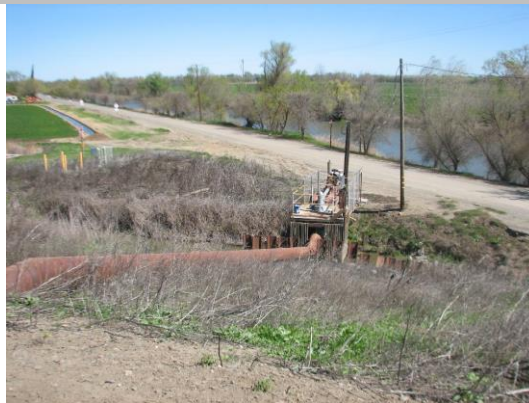
Photo 2 of 3 : UCIP_SP_2017_38984_59768.jpg

View of landward side.

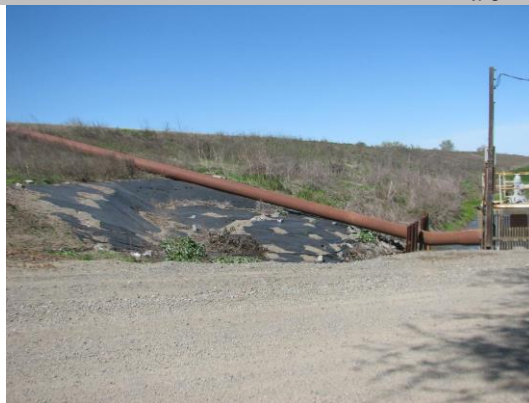
Photo 3 of 3 : UCIP_SP_2017_38984_59767.jpg

Item	DWR UCIP Field Study			38.641922 °	38.641922 °	
				-121.620884 °	-121.620884 °	
DWR ID						
Comment Code						
Inspector Comment						
FS_ID:38984 DS_ID:21151 EP_NO: 3277 Repair Type: Non-Urgent Crossing Status: Found UCIP Comments: Crossing appears to have been removed and replaced under maintenance back in 2008. No permit has been found--need to contact owner to obtain additional information about replacement. Landward slope sloughing--does not appear to be associated with crossing. Landward slope is being monitored by LMA. FIELD_STRUCT_DESC: 18-inch (not 20-inch as noted in desk study) steel drainpipe through the levee, 4.0 feet below the crown. Cutoff wall around pipe at center of levee. Siphon breaker on apex of pipe at waterward shoulder. Pump on pipe structure in drainage ditch at landward toe. Rock revetment on waterward slope. Pipe retained through levee and updates required to crossing under Permit No. 3277 (1960). FS Date: 3/18/2014

Pipe exposed on landward side.

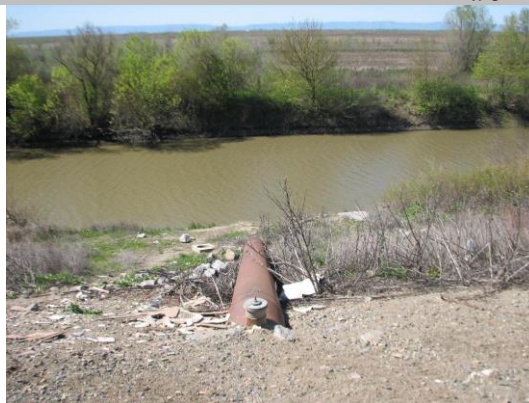
Photo 1 of 3 : UCIP_SP_2017_33032_59778.jpg

FS_ID:33032
DS_ID:21169
EP_NO: 5611
Repair Type: Non-Urgent
Crossing Status: Found
UCIP Comments: Crossing appears to have been removed and replaced under maintenance back in 2008. No permit has been found--need to contact owner to obtain additional information about replacement.
FIELD_STRUCT_DESC: [RD No. 827 Pumping Plant] 22-inch (not 24-inch as mentioned in desk study) steel drainpipe through the levee, 8.0 feet below the crown. CM cutoff wall around pipe at center of levee. Siphon breaker on waterward slope. Flap gate on waterward end. Pipe is exposed along waterward slope. (USACE-1955). This entry matches the Drainage or Irrigation Structure referenced in O&M manual (Station 3+75). Portion of pipe was removed and replaced, from landward side to waterward shoulder, under Permit No. 5611 (1968).
FS Date: 3/18/2014

Pipe exposed on waterward side.

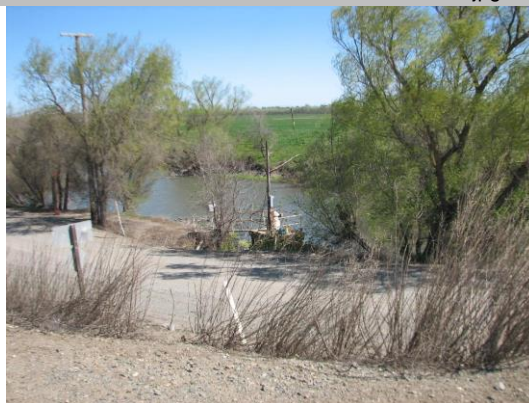
Photo 2 of 3 : UCIP_SP_2017_33032_59777.jpg

Pump station located on landward side.
